**CWA COMPLIANCE EVALUATION INSPECTION REPORT
U.S. ENVIRONMENTAL PROTECTION AGENCY, REGION 5**

Compliance Evaluation Sampling Inspection

FOIA Ex. 6 Dairy

June 2, 2014

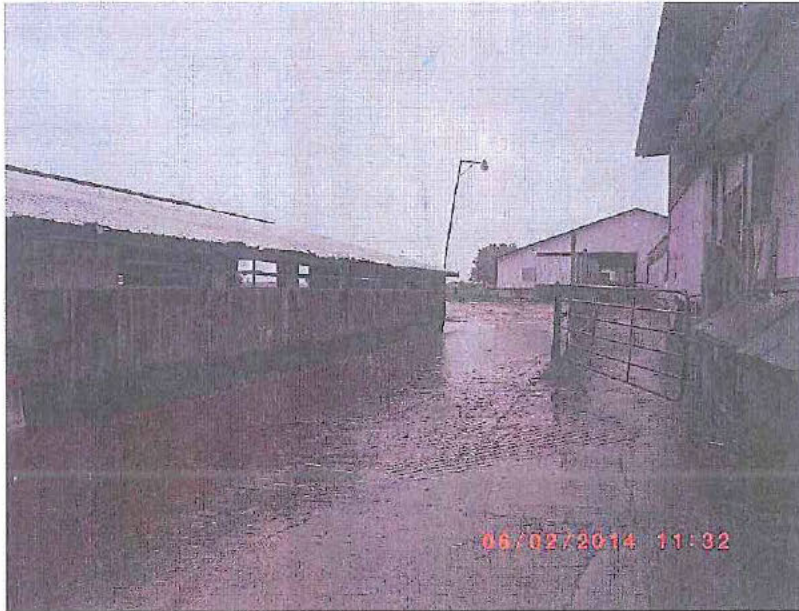
3: IMGP1094

Description: Large amount of standing storm water from precipitation between Heifer Barn and Milking Parlor.

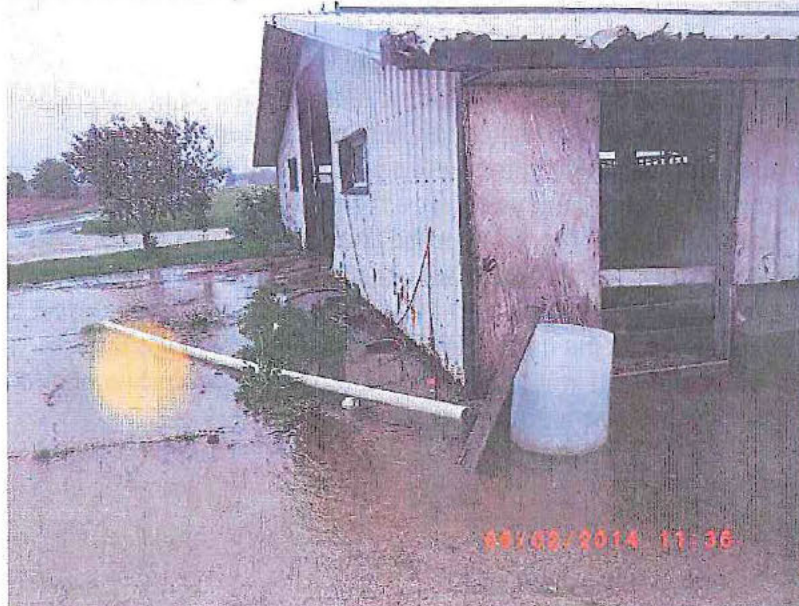
4: IMGP1095

Description: A pump inside white bucket pumps water from the large amount of standing storm water to a storm water ditch on the east side of the production area.

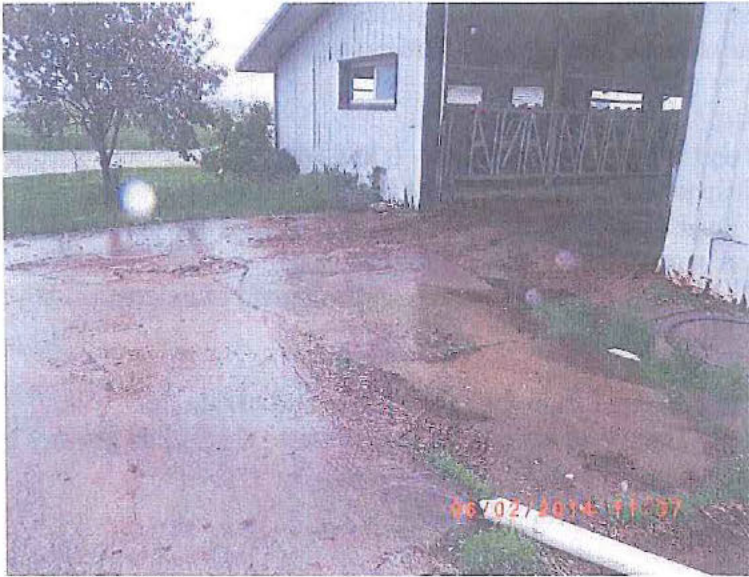
5: IMGP1096

Description: Northern door of Heifer Barn has track in and track out of manure and process wastewater. Water pumped from the between the barns outlets in front of the Heifer Barn and travels across the concrete to a storm water channel.

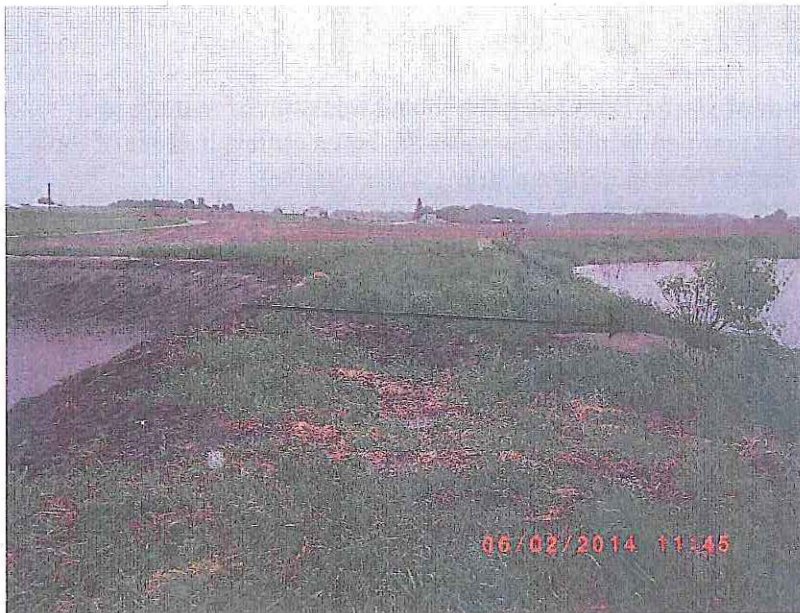
7: IMGP1101

Description: Manure flows from Pond #1 (on left) to Pond #2 via the channel between them.

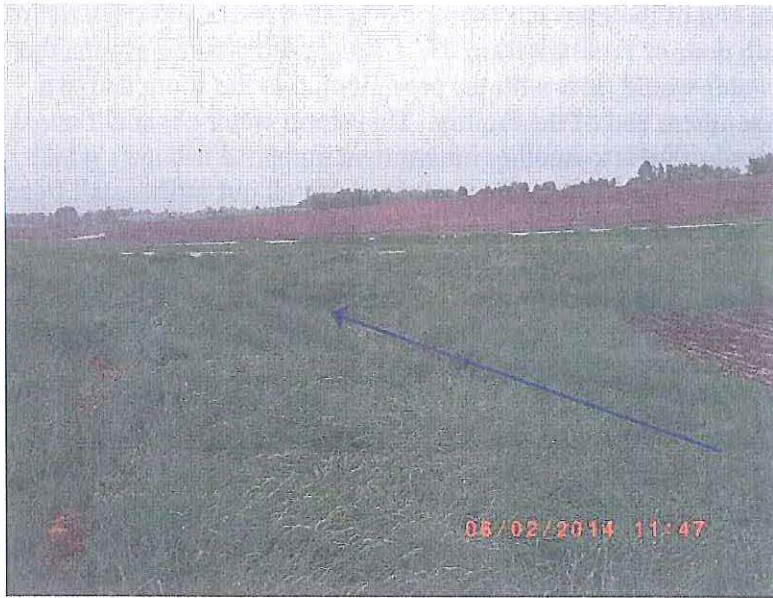
8: IMGP1102

Description: Vegetation on berms needs to be mowed. Storm water channel flows along the east side of the manure ponds.

1. The vegetation on the berms of the manure ponds is too tall to be able to observe the condition of the berms and watch for rodent holes that can compromise the integrity of the berms.
2. There are a few woody growth plants growing in the berms of the manure ponds which need to be removed so as to prevent conduits in the berm walls from their roots.
3. Carcasses from downed animals are discarded improperly. Process wastewater from the decomposing carcasses could flow with precipitation to the intermittent unnamed tributary south of the facility.
4. There were no permanent capacity depth markers in the manure ponds.

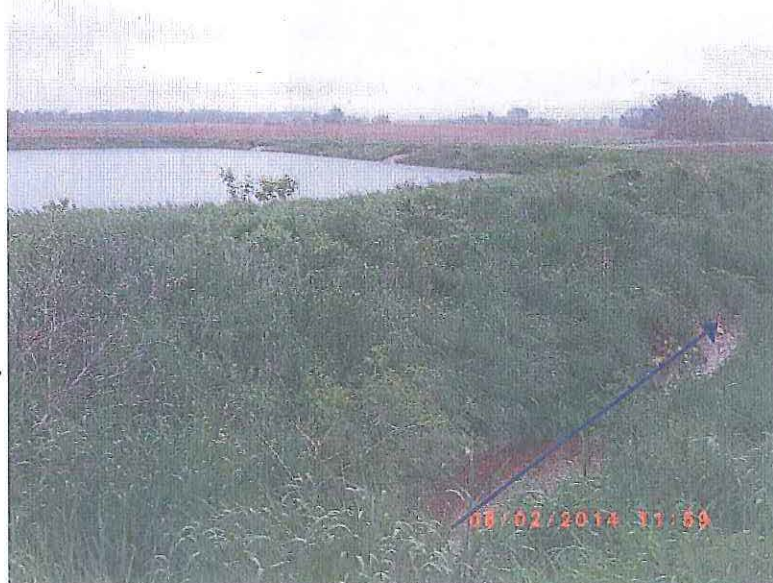
17: IMGP1106

Description: Storm water channel from the production area goes around the south side of the manure ponds and joins with the storm water channel on the east side of the production area.

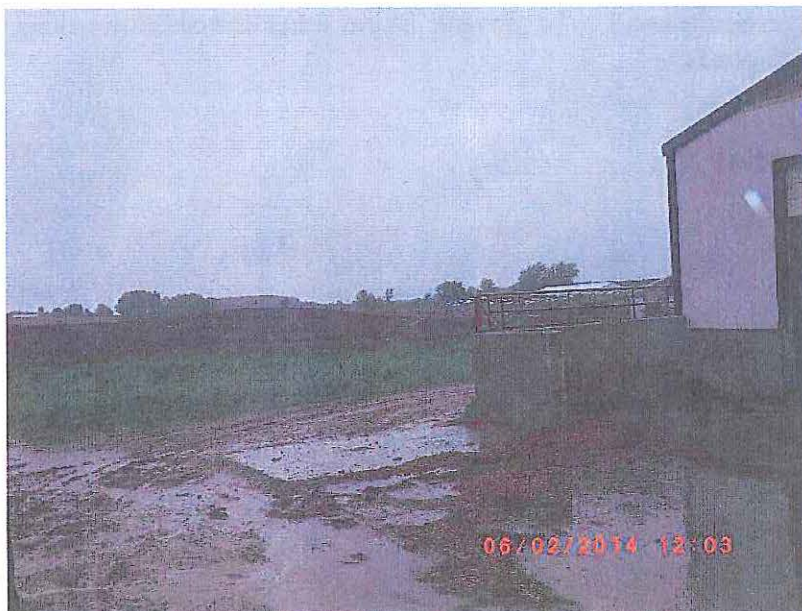
18: IMGP1107

EPA walked to the southern end of the Freestall Barns and noted track in and track out of manure and feed at the south door of Freestall Barn #3. During precipitation events, the manure and process wastewater would flow with the precipitation to the south and to a storm water channel at the southern end of the facility. This storm water channel flowed south and west through a stand of trees to another intermittent unnamed tributary which flowed to the east. EPA observed runoff from the track in and track out of Freestall Barn #3 flowing to the south.

Description: Track in and track out from south door of the Freestall Barn #3.

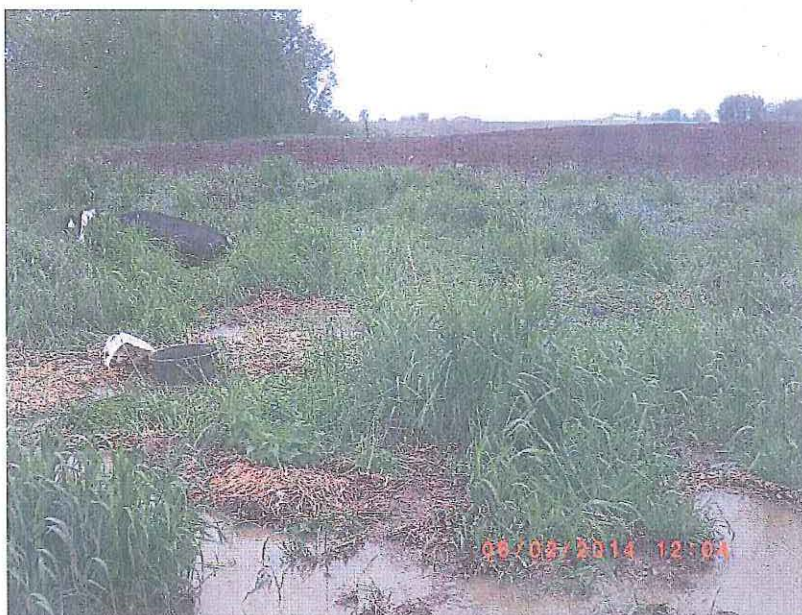
19: IMGP1108

Description: Runoff from track in and track out from Freestall Barn #3 flows to the south and to a storm water channel.

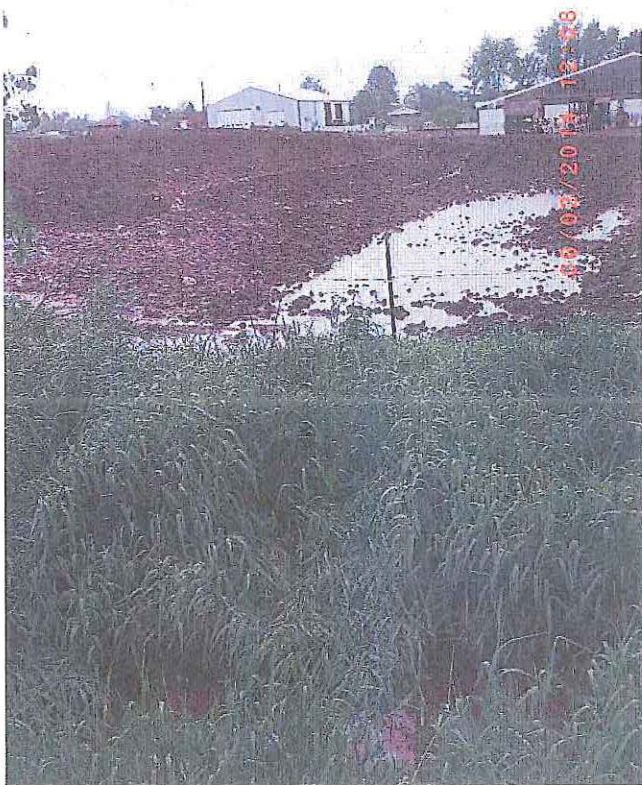
21: IMGP1110

EPA walked to the southern end of the feedlots south of the freestall barns. The feedlots were completely denuded of vegetation and runoff was observed flowing off the lots and into the storm water channel on the south side of the facility.

Description: Runoff from feedlots pools on the south side and then flows into the storm water channel to the south.

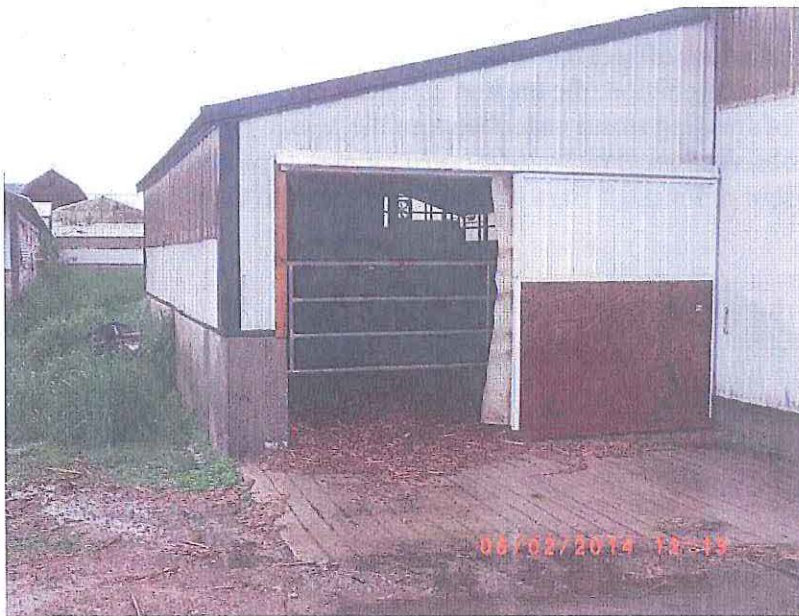
22: IMGP1111

Description: Maternity Barn on the west side of Freestall Barn #3. Track in and track out from the barn door flows with precipitation to the storm water channel to the south.

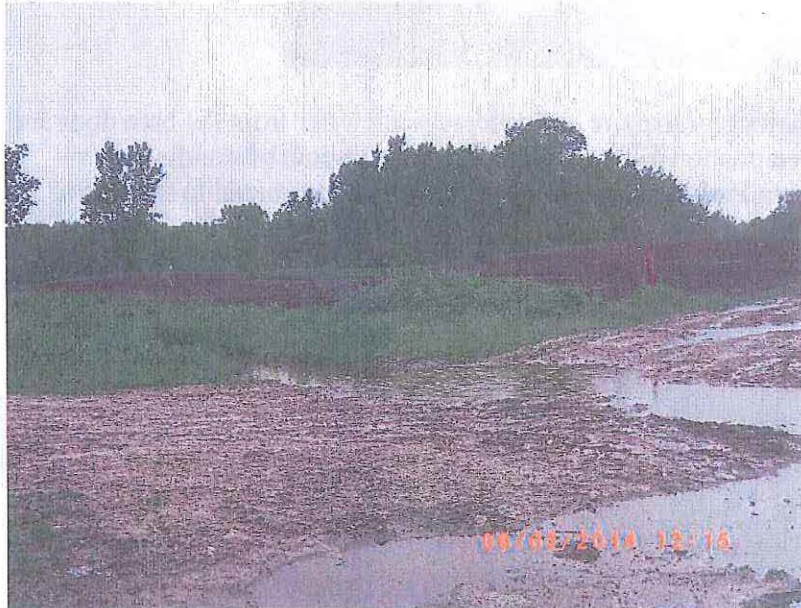
23: IMGP1112

Description: Process wastewater from track in and track out from barn doors flows to the south to the storm water channel.

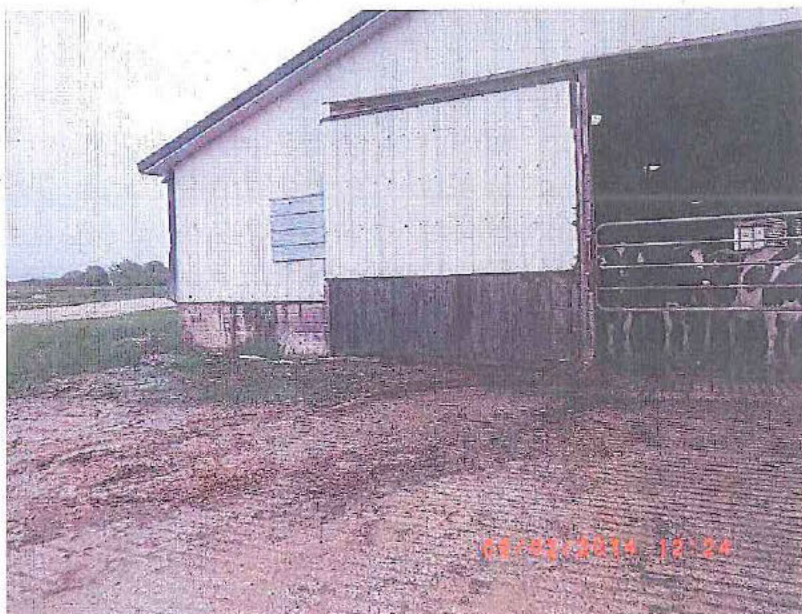
24: IMGP1113

Description: No containment for manure and process wastewater from the barn door and runoff can flow with precipitation to the north to the large amount of standing storm water between the Milking Parlor and the Heifer Barn which is pumped to the storm water channel.

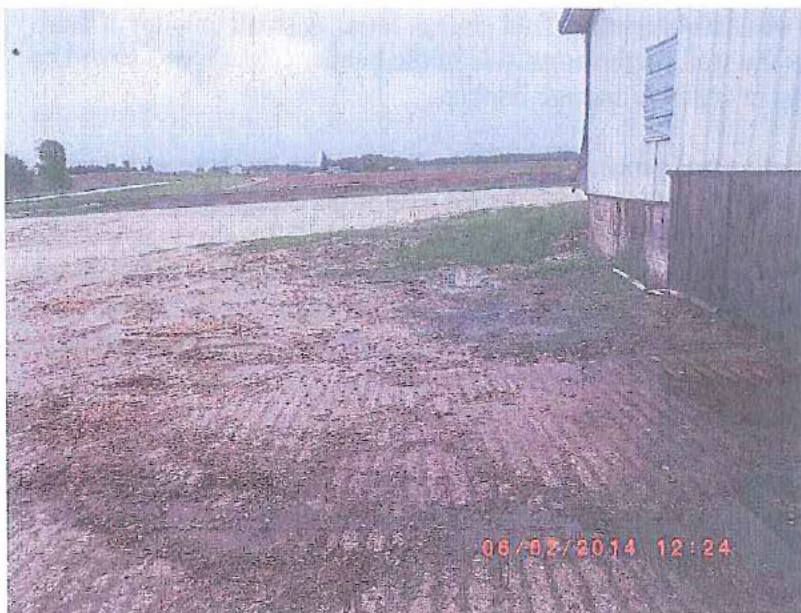
25: IMGP1114

Description: Manure and process wastewater is not contained in the barn.

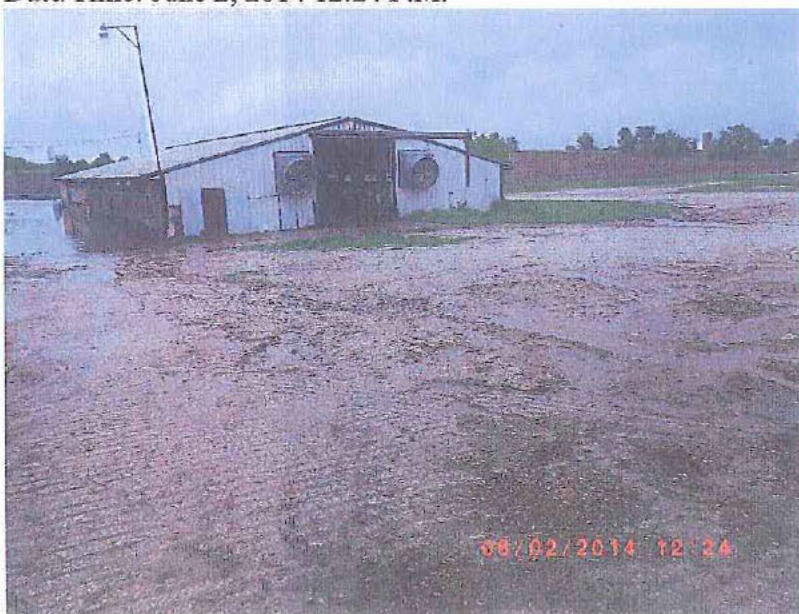
26: IMGP1115

Description: Manure and process wastewater from Freestall Barn #2 flows to the north with precipitation. Note the large amount of standing storm water to the left of the barn. This large amount of standing storm water has a pump in its north side.

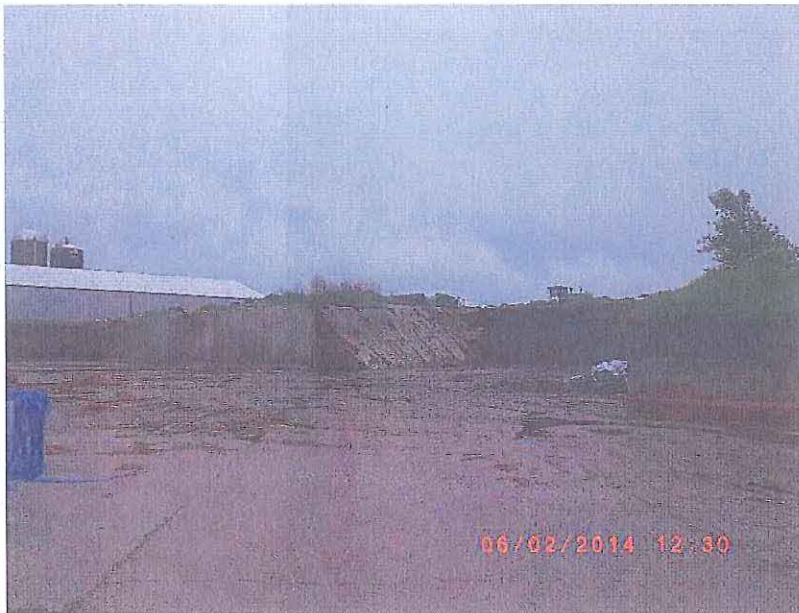
29: IMGP1118

Description: Silage is stored in under tarps in concrete storage bunkers.

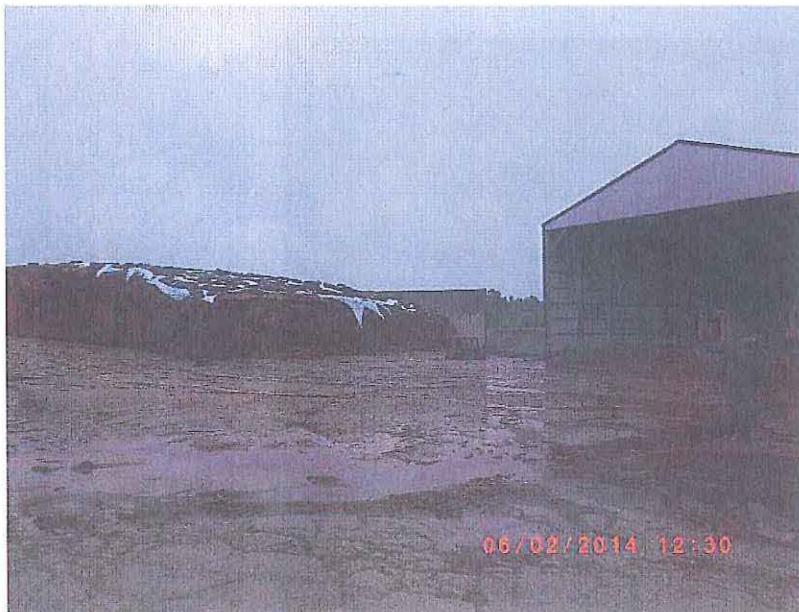
30: IMGP1119

The first flush of precipitation and process wastewater from silage leachate was designed to flow to a tank that was buried below the northwest side of the Silage Pad. Flow was to enter the tank via a 4" pipe inlet that was flush with the ground. EPA observed that the inlet was blocked by debris and none of the process wastewater from the Silage Pad was entering the pipe. Instead, the flow continued to the west and entered a 12" storm water pipe at the northeast corner of the Hay Barn which was also flush with the ground. EPA observed a distinct plume of process wastewater from precipitation mixed with silage leachate flowing into the storm water pipe.

Description: Silage leachate flows toward a hole that is designed for first flush capture.

Inlet hole location is where the person is standing.

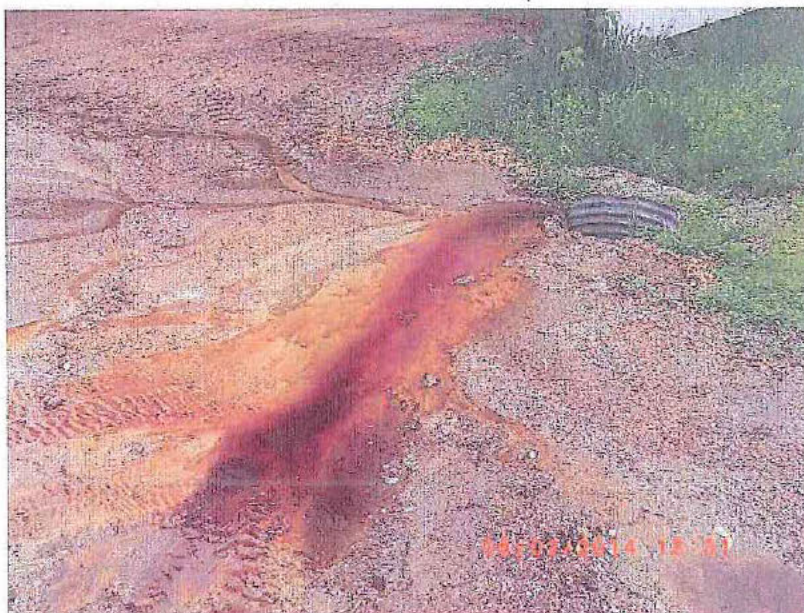
31: IMGP1120

Description: Silage leachate bypassed the small hole for first flush and flowed to a storm water pipe.

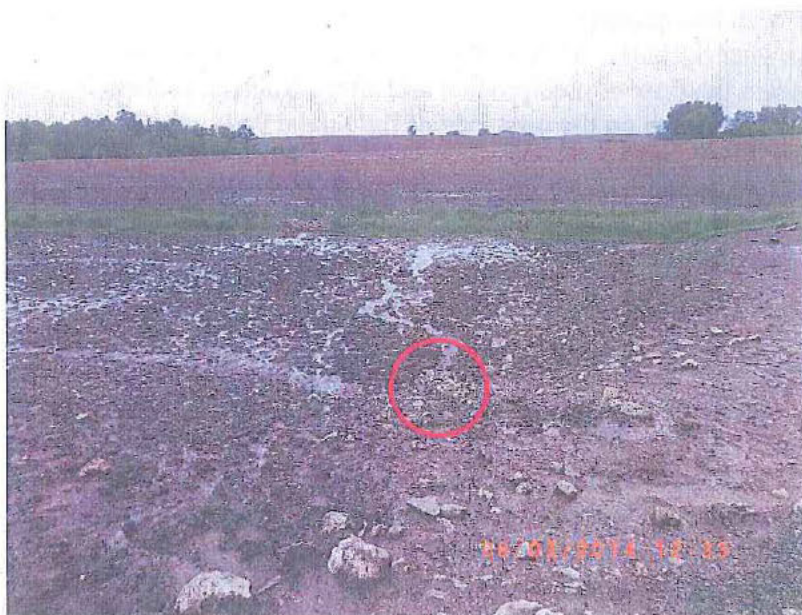
33: IMGPI122

The storm water pipe outlet was located in the hillside south of the Hay Barn. The mixed process wastewater and storm water exited the pipe and flowed down the hill and to a ditch on the west side of the facility. This ditch flowed to the south and into the intermittent unnamed tributary on the south side of the facility.

Description: Storm water pipe outlet in the hillside south of the Hay Barn (red circle).

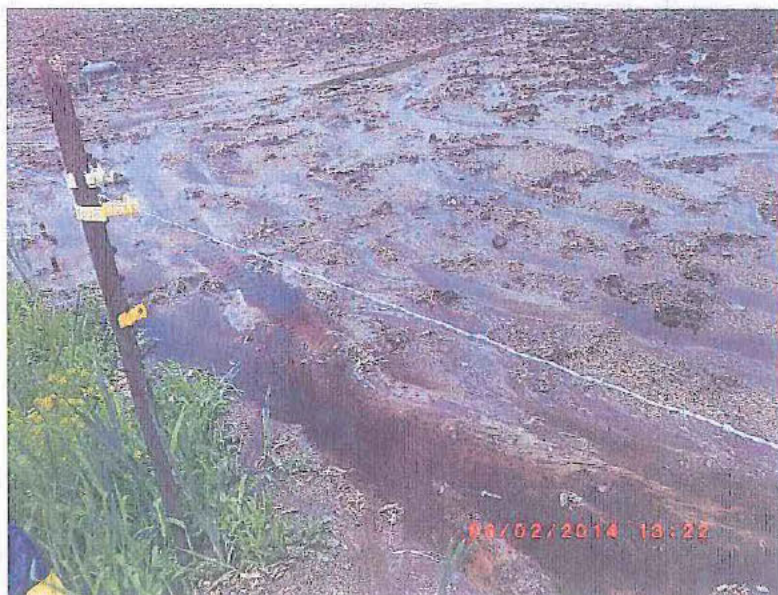
38: IMGPI127

Description: Flow of process wastewater from the outlet of the storm water pipe in the Silage Pad to the hillside south of the Hay Barn.

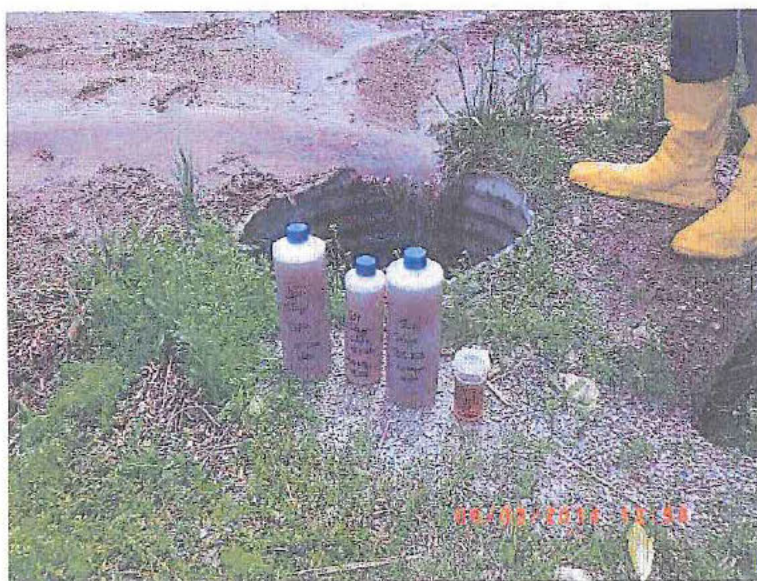
34: IMGP1123

Description: Sample S01, "Silage", taken at 12:55 P.M. from the flow of precipitation and silage leachate process wastewater into the storm water pipe on the west side of the Silage Pad.

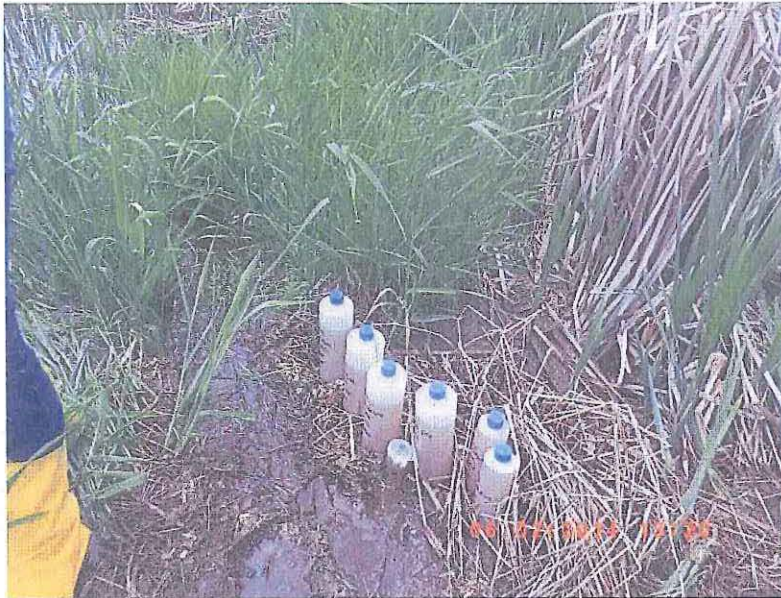
36: IMGP1125

EPA walked to the west and took the second sample, S02, named "Confluence w/Ditch", at 1:08 P.M. from the flow of process wastewater after flowing out of the pipe and down the hillside as it flowed into the ditch on the west side of the facility. A duplicate sample, S03, named "Duplicate S02", was also taken in this location.

Description: Sample S02, "Confluence w/Ditch", was taken at 1:08 P.M. from the runoff pathway from the outlet of the storm water pipe from the Silage Pad to the ditch on the west side of the facility. Sample S03, "Duplicate S02" was also taken here.

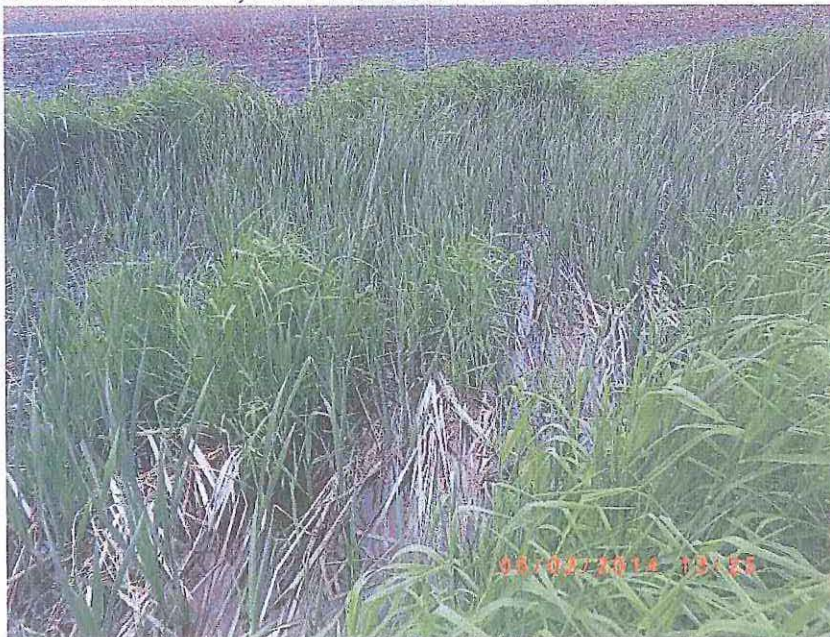
44: IMGP1133

Description: EPA observed continuous water connection in the ditch on the west side of the facility.

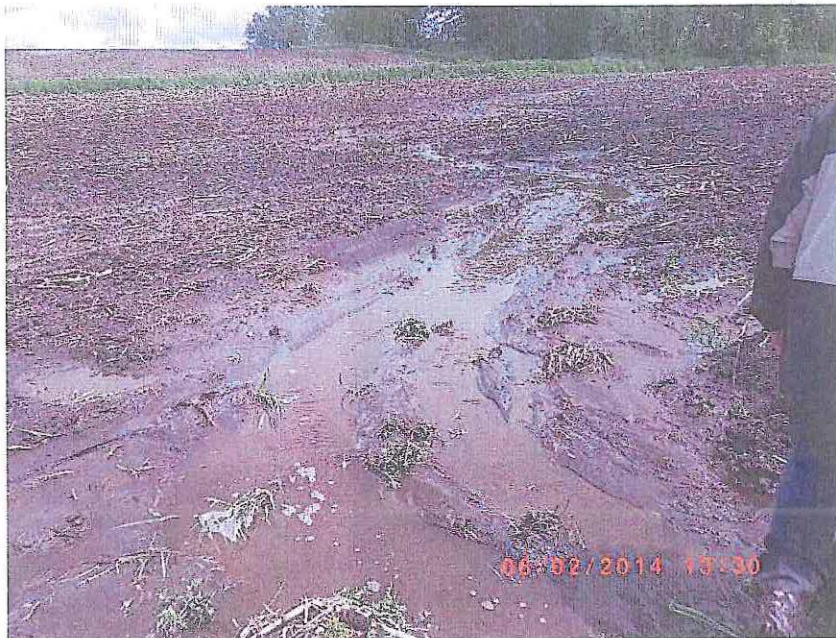
54: IMGP1143

Description: Field runoff to the ditch on the west side of the facility.

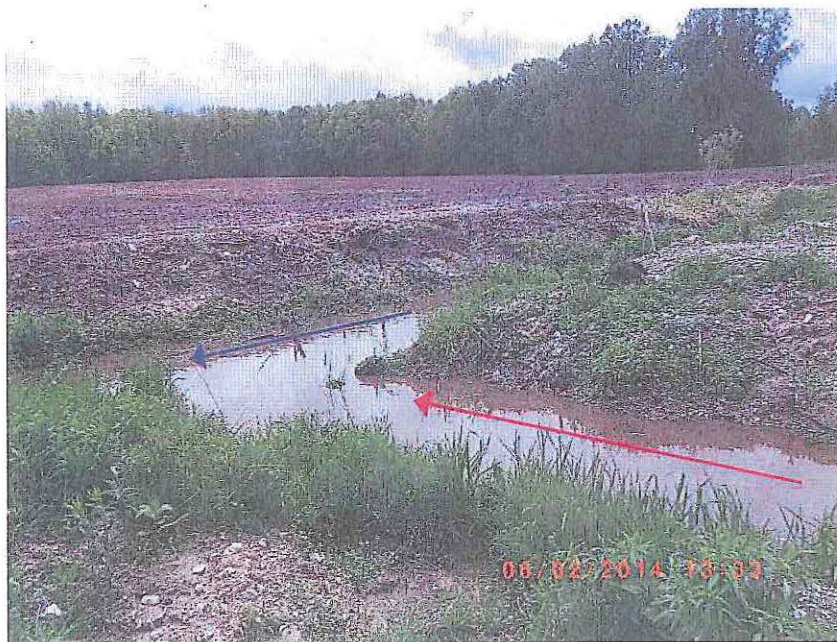
58: IMGP1147

Description: The confluence of the ditch on the west side of the facility (red arrow) with the intermittent unnamed tributary (blue arrow).

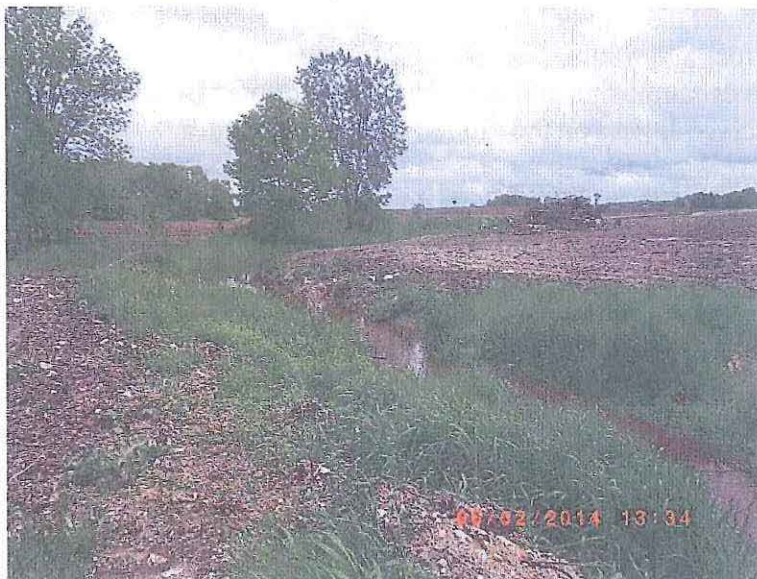
60: IMGP1149

Description: Looking downstream at the intermittent unnamed tributary from the confluence with the ditch on the west side of the facility. Note that there is a distinct bed and bank in the tributary.

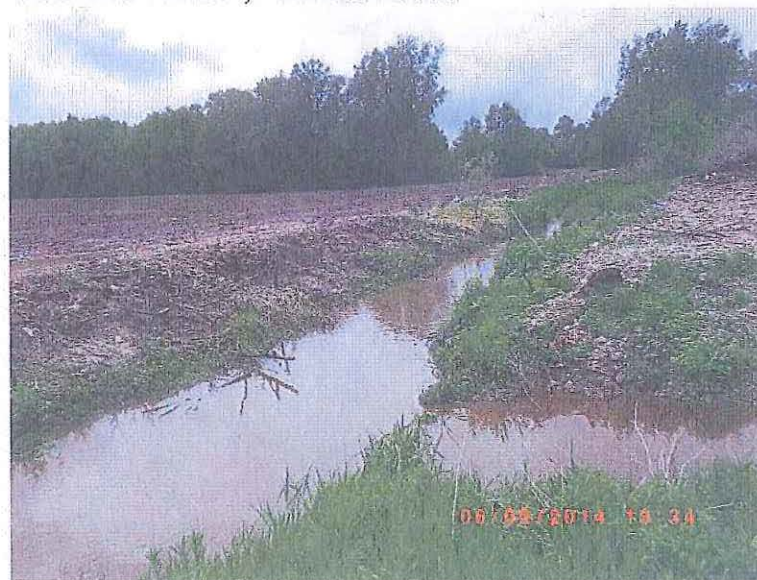
61: IMGP1150

Description: Looking upstream at the intermittent unnamed tributary from the confluence with the ditch on the west side of the facility.

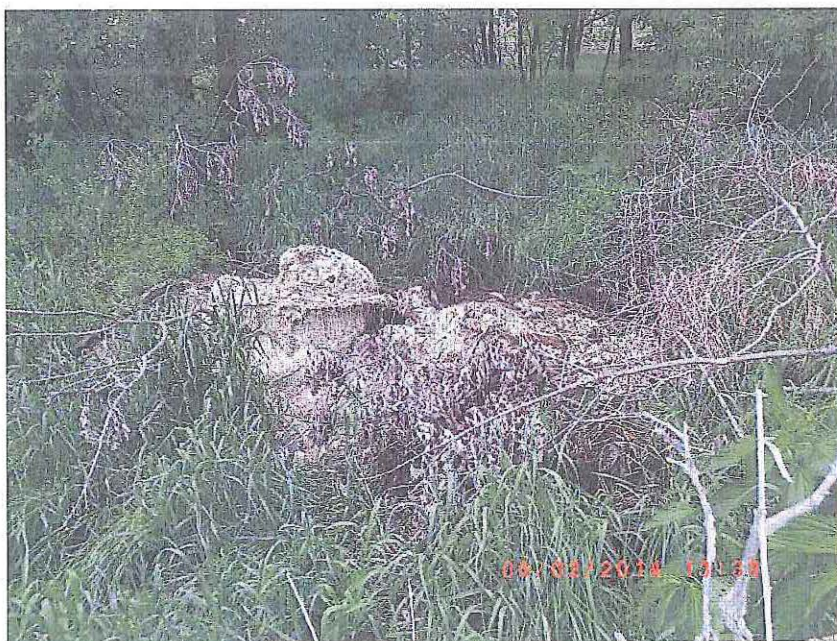
62: IMGP1154

EPA walked east and north toward the stand of trees. EPA walked on the south side of the stand of trees and came across a mortality pile. The mortalities were not covered properly or buried. They were decomposing and covered with maggots. Bones from the scavenged carcasses were observed laying on the ground near the carcasses.

Description: Mortalities left to decompose in the trees south of the feedlots.

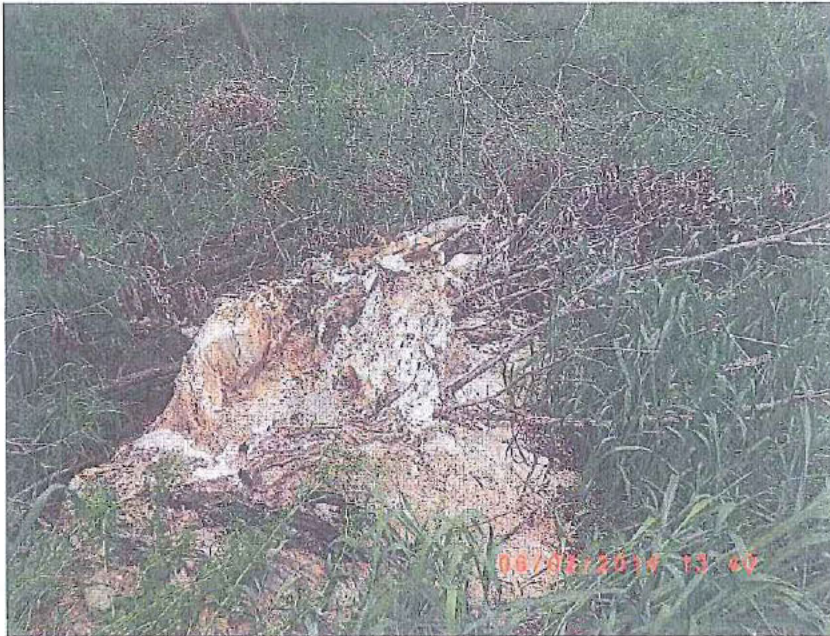
63: IMGP1155

The facility owner stated that he had given his workers downed cows to cut up and eat and the carcasses were left over from that.

Description: Facility owner stated that these were carcasses from downed cows that he let his workers cut up and eat.

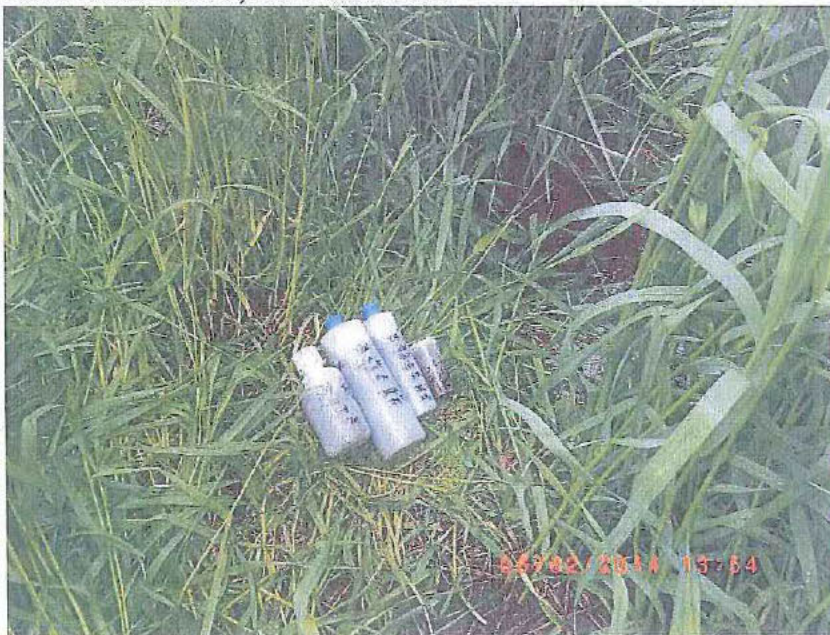
68: IMGP1160

When EPA arrived at the southern end of the feedlots where the runoff from the feedlots was flowing into the storm water channel, EPA took the fourth sample, S04, named "Feedlot Runoff" at 1:50 P.M.

Description: EPA took sample S04, "Feedlot Runoff", at 1:50 P.M. from the flow of runoff from the feedlots into the storm water channel south of the facility.

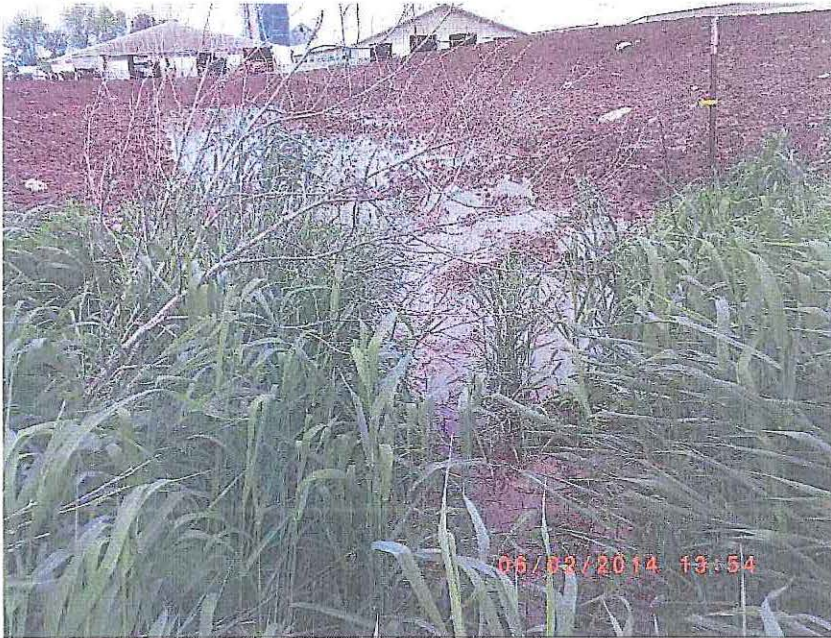
70: IMG1162

Description: Flow of runoff from the bare feedlots goes into the storm water channel south of the facility.
